Incident Analysis

MEGA-WAREHOUSE FIRE

9590 Allpoints Parkway | Plainfield, Indiana

MARCH 15, 2022

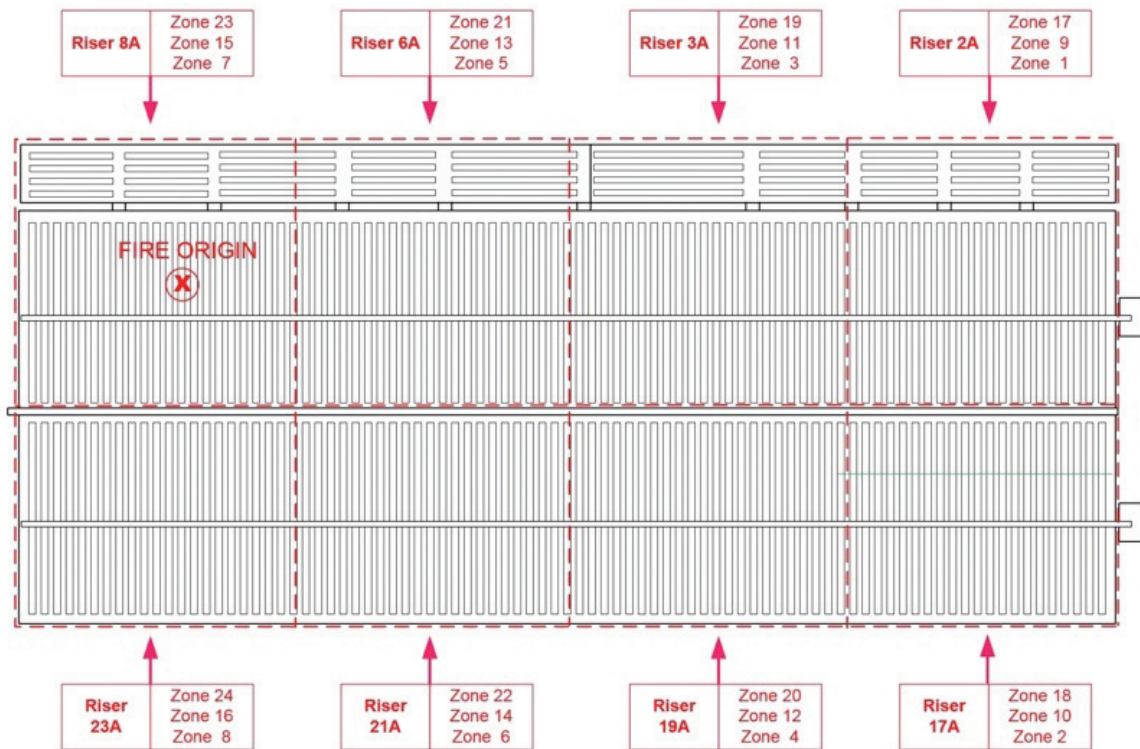
Figure 13: The Pick Module was protected by eight CMDA sprinkler systems. Each system was divided into three zones to cover the three lower levels of the structure.

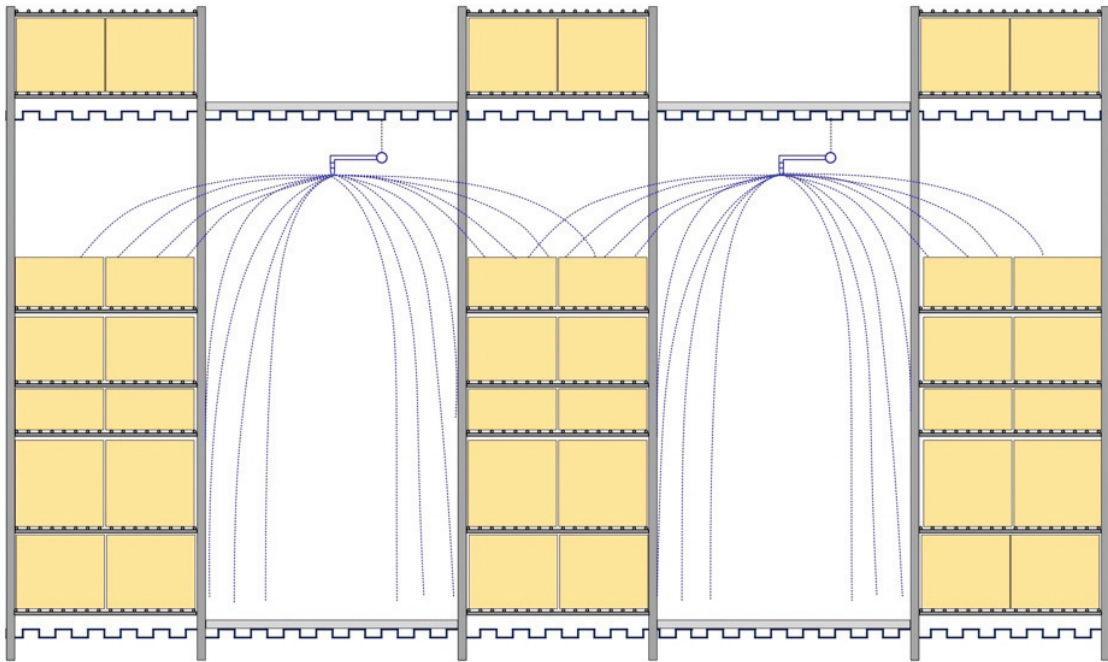
The shelves were constructed of open steel grating to allow water from the sprinklers to flow down to reach the goods that were stored on the lower shelves; however, the tight packing of goods on the shelves would tend to limit the amount of water that could reach the lower levels.

Figure 15: The Pick Module sprinklers were positioned to discharge water onto the top level of the stored goods and to cover the vertical faces on each side of the aisles.

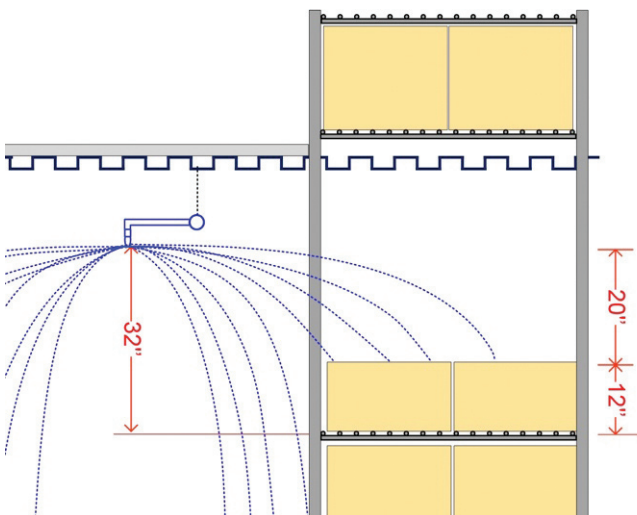
The sprinkler plans indicate that the deflectors of the pendant heads were positioned 32" above the top shelves. The maximum height limit of 12" for boxes stored on the top shelves provided for a minimum clearance of 20" to avoid obstruction of the sprinkler discharge pattern. In storage areas it is always important to ensure that there are no tall items encroaching on the required space and blocking the sprinkler distribution pattern.

Figure 16: The 12" height limitation for goods placed on the top shelves was required to provide 20" of unobstructed space for the sprinkler discharge pattern.

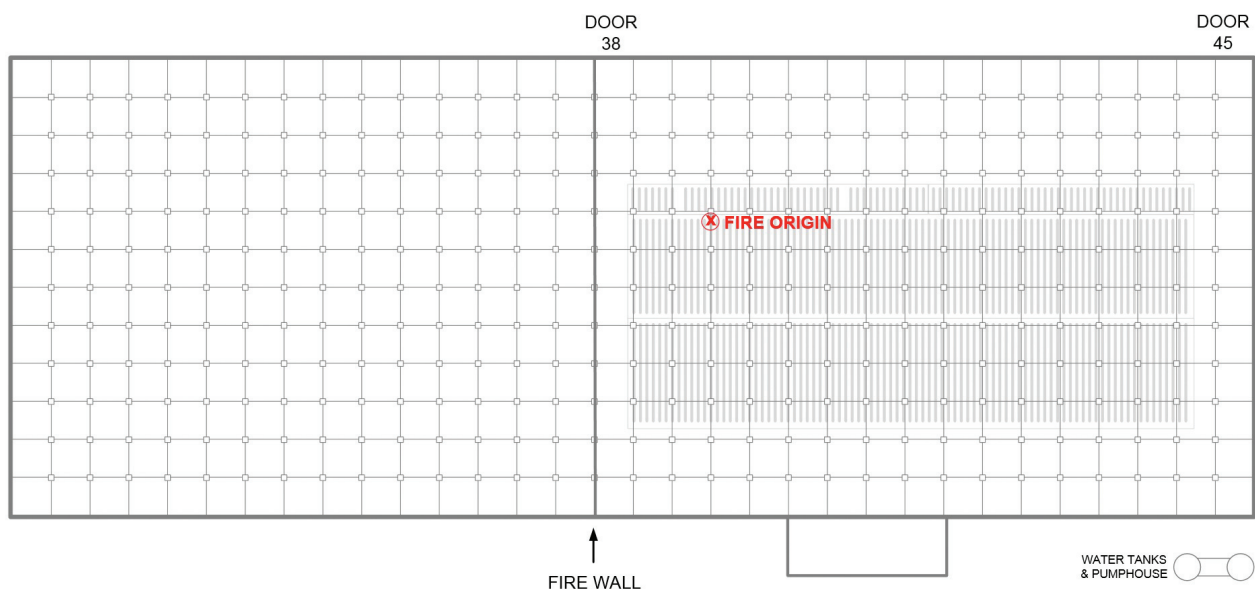
Figure 17: Responding units were originally directed to door 45 and were redirected by employees to enter through door 38. This door was approximately 350 feet from the fire area on the 2nd level of the Pick Module; however, the direct path was obstructed by stored goods and a complex system of conveyors.

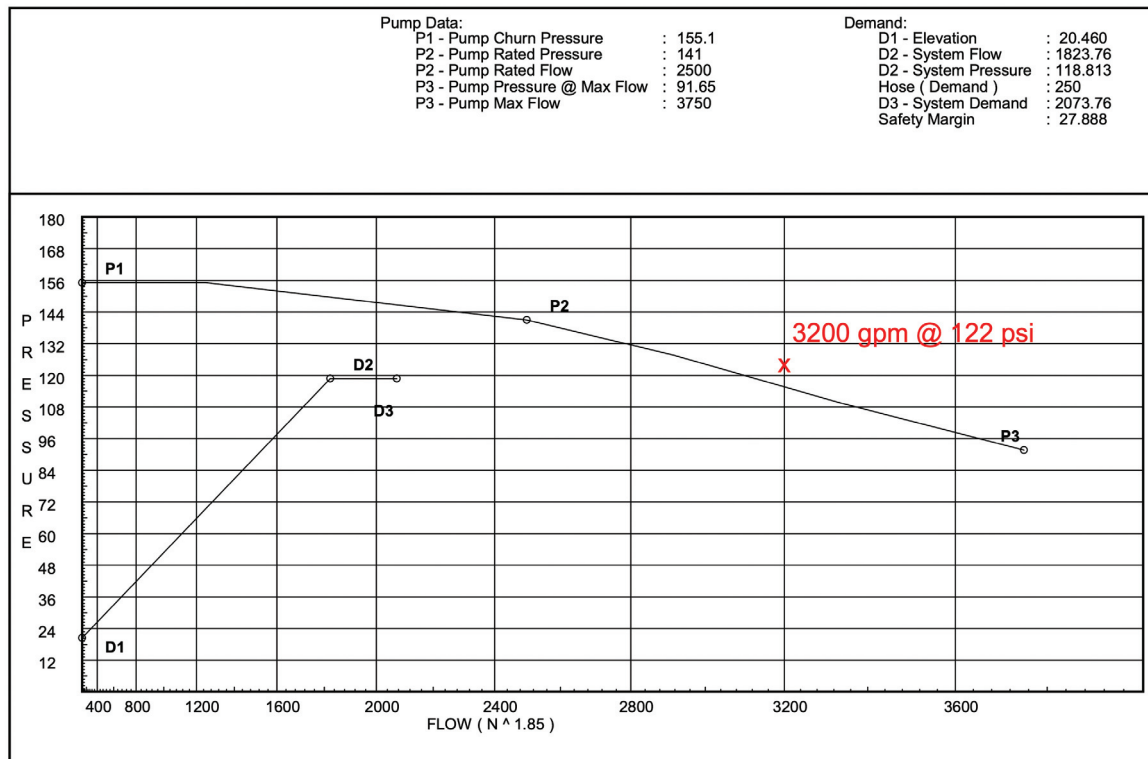
The engine company that was in position to pump into the fire department connection to provide additional water for the sprinklers did not initially charge the lines, because the fire was reported to be under control by the time their lines were in place. When the situation changed, the lines were charged, but it was already too late to make a difference.

Figure 17. The water supply curve that was derived from a pump test after the fire indicates that the combined design flows from the ESRF and Pick Module sprinklers probably would have exceeded the available supply with one fire pump in operation.
